## Beach Restoration at Grand Velas Hotel, Riviera Maya, Mexico

Raul Lopez<sup>†</sup>

<sup>†</sup>Tecnoceano

Lopez, R., 2014. Beach restoration at Grand Velas Hotel, Riviera Maya, Mexico. In: Silva, R., and Strusińska-Correia, A. (eds.), *Coastal Erosion and Management along Developing Coasts: Selected Cases*. Journal of Coastal Research, Special Issue, No. 71, pp. 86–92. Coconut Creek (Florida), ISSN 0749-0208.

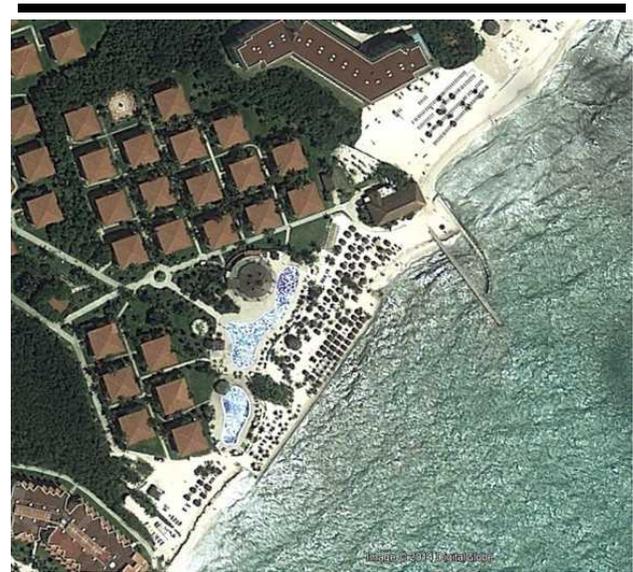
Figure 2. Coast line over the same area about 2.8 km north from Grand Velas Hotel, the jetty keeps the sand at the south part of the beach, this proves that sand moves from south to north primarily, even though there is movement in both directions.

The beach has been widened and it narrows a little with the different local wave conditions, so it has reached equilibrium. The sea bottom is rocky and no sand banks are found close to the study zone, sand moves only alongshore in both directions predominantly from south to north as it is possible to observe in Figure 2, which shows the coastal line in front of another hotel at the same zone about 2.8 km north from Grand Velas Hotel. That hotel has a jetty where the south part of the beach is wider to the south and narrow to the north because sand is coming from the south. Neighboring beaches are still being eroded every year nevertheless the Grand Velas Hotel beach is wide and pleasant Figure 3.

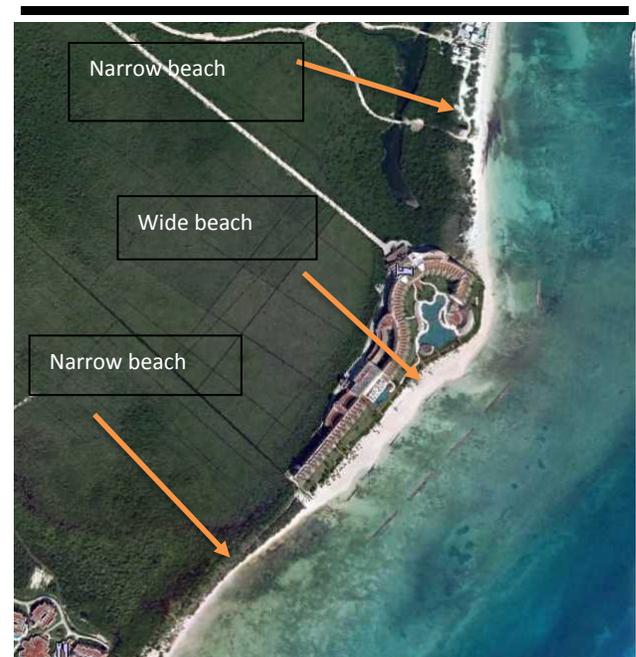
Figure 3. From this satellite photo, it is possible to observe that southern neighboring and northern neighboring beaches are narrow while the protected beach is wide.

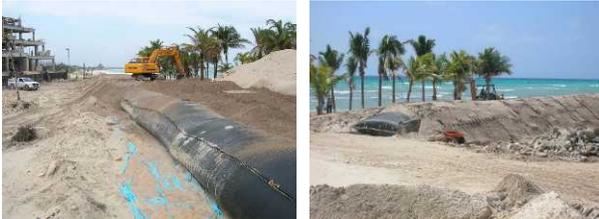
- a) Geotubes filled with sand and covered with beach sand
- b) Dune cover and slope formation

Figure 13. Construction of artificial dune.

The artificial dune and the breakwaters were built in 2008. Figure 13 and Figure 14 show the building stages and the final view of the dune.

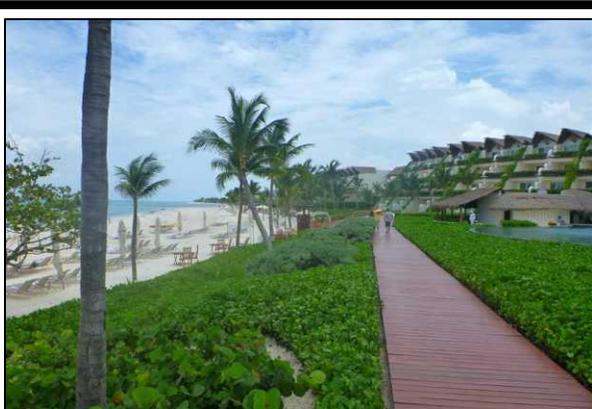
Figure 14. View of artificial dune in front of the hotel.

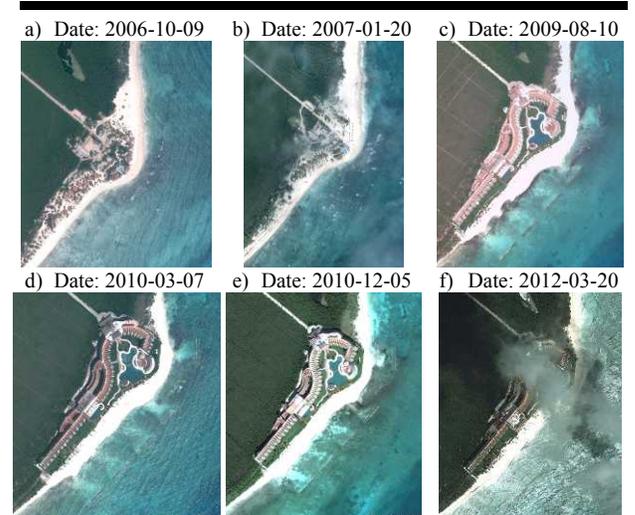
Figure 16. Images c, d, e and f show that the beach protected by the breakwaters is wider and remains wide over several years, this proves that this sand is very stable, and even though topography is not realized on a yearly basis, the satellite pictures from Google Earth show clearly the shape of the beach.

Comparing topography from 2008 (with the project finished) and 2013 (the only data available), the amount of sand captured by the structures was calculated and the result is 15,867.20 m<sup>3</sup> of sand over five years, Figure 15 shows the beach profile comparison, this volume seems to be stable most of the time just as it is observed in Figure 16.

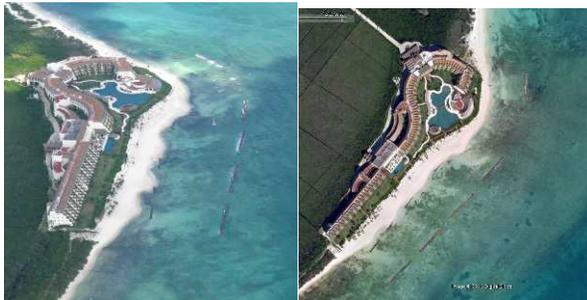
Figure 18. Aerial photos of the beach at the Grand Velas Hotel 2009  
 a) A wide beach with space enough to have chairs on the beach for guests, is visible. Note that the protected area is a lot wider than the unprotected beach to the south and to the North. Salients are visible and the North point looks wide but not as wide as the rest of the beach (November 2009). b) A wide beach with no salients, the north point is not so wide probably due to the big gap between breakwaters 4 and 5 (February 2010)

The beach at the Grand Velas Hotel in 2009 is shown in Figure 18a and in 2010 in Figure 18b. In 2009 better salients were formed, while in 2010 an even shoreline with small salients were observed.
